TEST REPORT

Report No.: HC50030A/2021 Page: 1 of 12 Date: August 23, 2021

Fanless Embedded Box PC ECX-2200/ No.1, No.2 Total 2 sets May 7, 2021 to Aug. 9, 2021 System Configuration of Equipment under measurement: CPU: Intel(R) I7-10700E, 2.9GHz RAM: innodisk DDR4 2666 8GB SDD: innodisk 2.5" SATA SSD 3ME4 128GB

- 1. Low Temperature Test
- 2. High Temperature Test
- 3. Random Vibration Test
- 4. Mechanical Shock Test

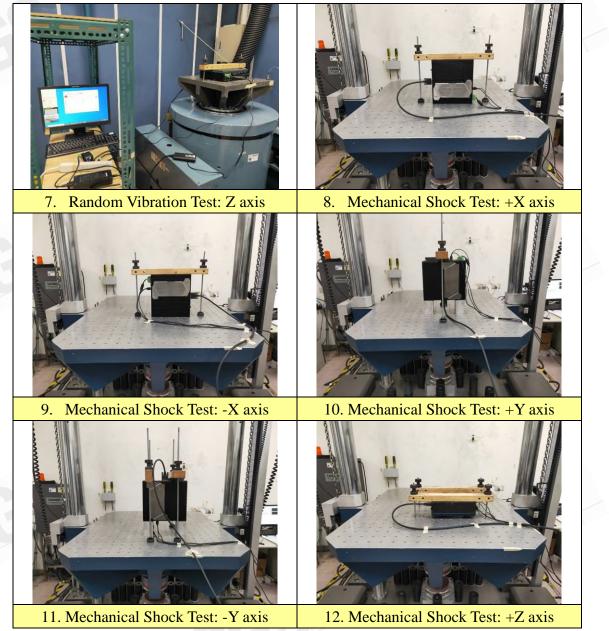
Test Photos--Continued:

Sample condition:	Operating (exec	ute " Burn ln Tes	<u>t")</u>	
Wave form:	Random			
Frequency:	<u>(5 ~ 500) Hz</u>			
	Frequency (Hz)	Left Slope (dB/ Oct.)	PSD (g ² /Hz)	Right Slope (dB/ Oct.)
	5	_	0.05	0
	500	0	0.05	_
	→ equivalent	t to 5.0 Grms		
Direction:	X, Y, Z axes (se	e photo 5 ~ 7)		CIT
Duration:	30 minutes/ axis	<u>8</u>

Test method:	IEC 60068-2-27 Edition 4.0:2008 and client's request
Sample condition:	Operating (execute " Burn In Test ")
Pulse shape:	Half-Sine
Acceleration:	<u>50 g</u>
Pulse duration:	<u>11 ms</u>
Shock direction:	<u>6 faces ($\pm X$, $\pm Y$, $\pm Z$ axes, see photo 8 ~ 13)</u>
No. of shock:	3 shocks/ axis (total 18 shocks)
